Capital Reserve Analysis Willow Park Condominium

G & M Engineering, Inc.

April 2024

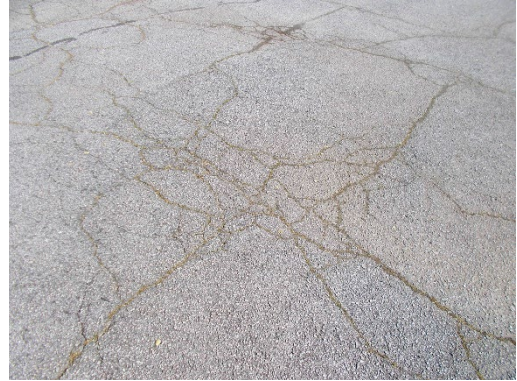
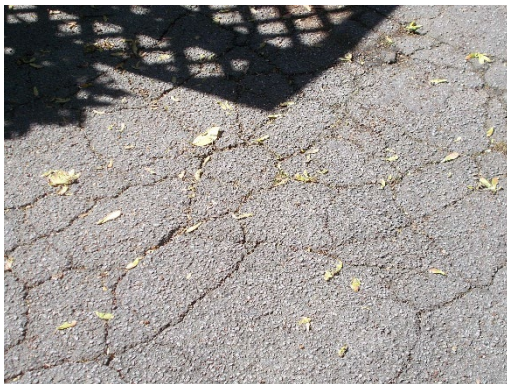
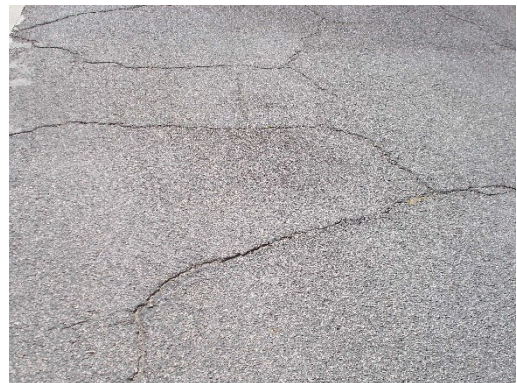
Asphalt Parking Area - The asphalt parking areas and driving areas within the community consists of a gravel base covered with asphalt surface course material. The parking area was observed to be in fair to poor condition with major deterioration observed in numerous locations at the private parking areas and drive areas. There have been patches of asphalt installed at some locations in the past, but the

current asphalt surface is at its useful life end. The typical useful life of an asphalt roadway/parking area is approximately 25 years depending upon the vehicular traffic

on the asphalt, underlying base conditions and maintenance. We have included the maintenance budget of crack sealing and patching every six years to help prolong the useful life of the asphalt at the community. The milling of the surface of the asphalt and replacement with a new layer of surface asphalt will be one of the more expensive items that the Association will be required to undertake. The milling of the surface course of the asphalt is a

process to grind the top surface 1.5" to 2" of the asphalt parking lot and then replace the removed asphalt with a new layer of asphalt.

The areas where the asphalt is severely deteriorated (see the pictures) will require that the asphalt and base material be removed, and the area patched prior to the milling and overlay project. This budget has been provided to occur in 2025. The cost of this project in 2025 will be more than \$40,000. This is the reason for maintenance on the asphalt surface to prolong the useful life as long as possible.

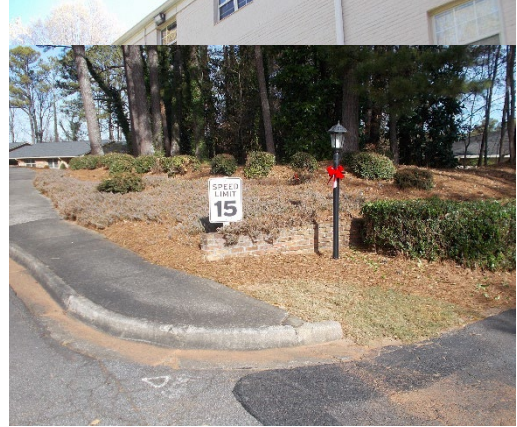
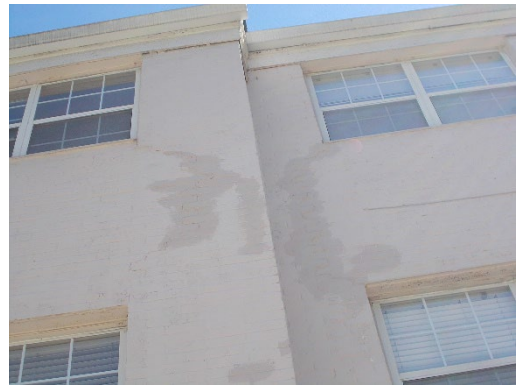
Buildings - The buildings consist of primarily three-story wood-framed structures that are clad with brick veneer and wood trim and some siding accents. The overall condition of the buildings is fair with the old siding in poor condition and the buildings requiring painting due to peeling paint and rotted wood trim. The new materials to replace the rotted wood trim should be composite materials where possible to help reduce the future expenses of the Association due to wood rot. The Association should, when performing exterior restoration projects, be mindful of products that are more sustainable and will not rot or decay. These types of products may have a higher initial cost; however, the cost benefit in the long term will cause the Association to have less maintenance cost in the future. Another area of concern with the buildings are the cracks in the brick in some areas that will require repair (tuck pointing) prior to a new paint project being undertaken.

We have included several budgets for the buildings to include the shingle roof replacements, gutter and downspout replacements, exterior painting and repair, common corridor front painting, common corridor front carpet replacement, common corridor rear painting and restoration of the laundry rooms. All budgets are based upon the conditions observed at the property.

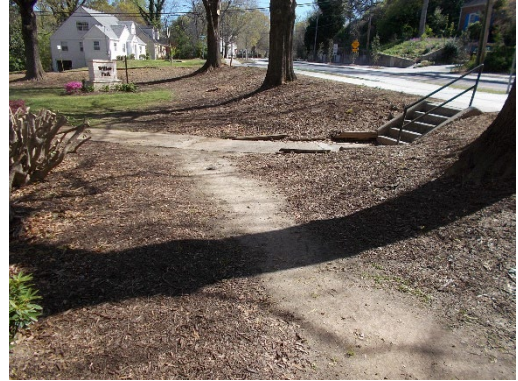
The drainage at the community consists of a sheet flow on landscaped areas and parking areas and concentrated flow along the curbs and grassed swales. The storm water is then collected into catch basins and drain inlets and transported by underground pipes to discharge locations off-site. From our review of the drainage on the property, we found that the system requires inspection and upgrade along the front of the buildings to provide adequate collection of the water and transport off property.
